## **Dust Abatement Methods for Lines- of-Communication and Base Camps in Temperate Climates**

John F. Rushing, Vernon M. Moore, Jeb S. Tingle,  
Quint Mason, and Tim McCaffrey

October 2005

Final report

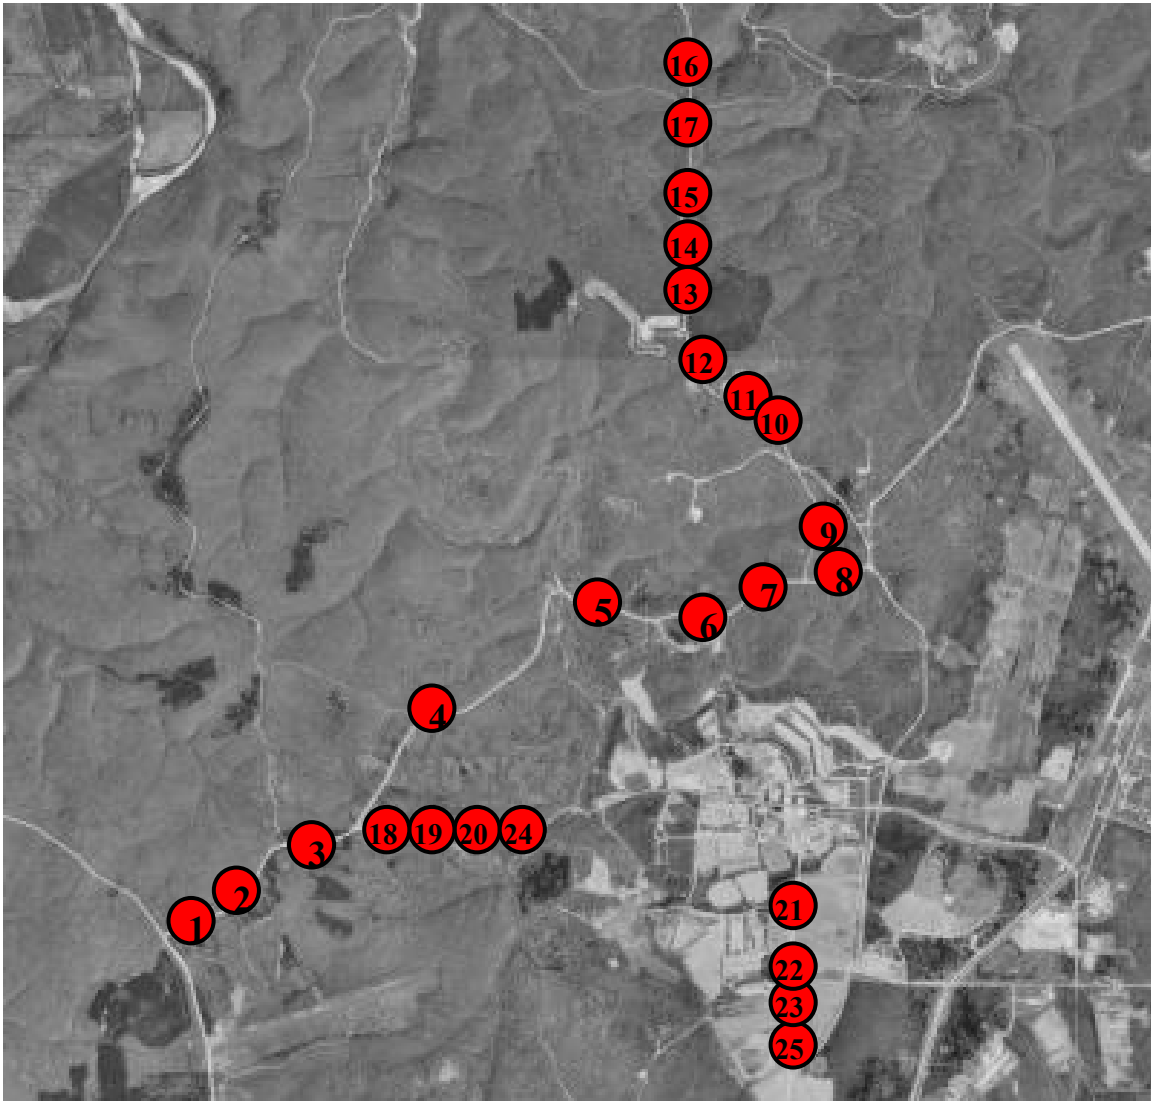
Figure 1. Layout of test sections

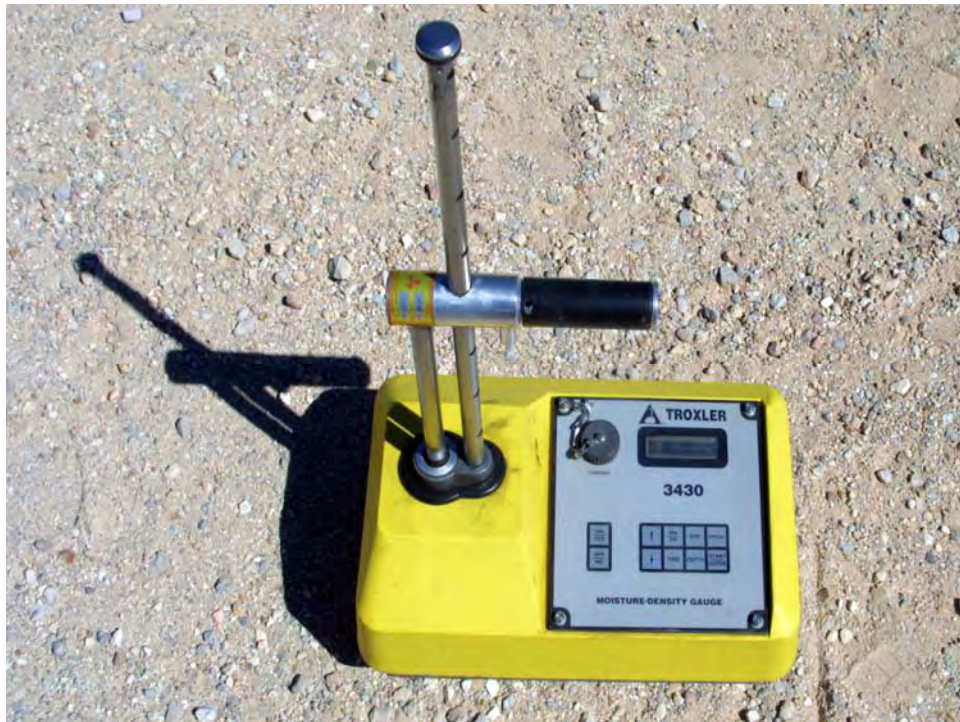
Photo 1. Troxler 3430 nuclear density gauge

A Troxler® 3430 nuclear gauge was used to collect density and moisture data in the center of each test section prior to construction and after each evaluation period (Photo 1). The gauge contains two radioactive sources: Cesium-137 for density measurement and Americium-241:Beryllium for determining moisture content. Density measurements were taken in the 6-in. direct transmission mode after creating a hole in the section using a drill rod according to ASTM D2922. Moisture contents were obtained using procedures outlined in ASTM D3017.

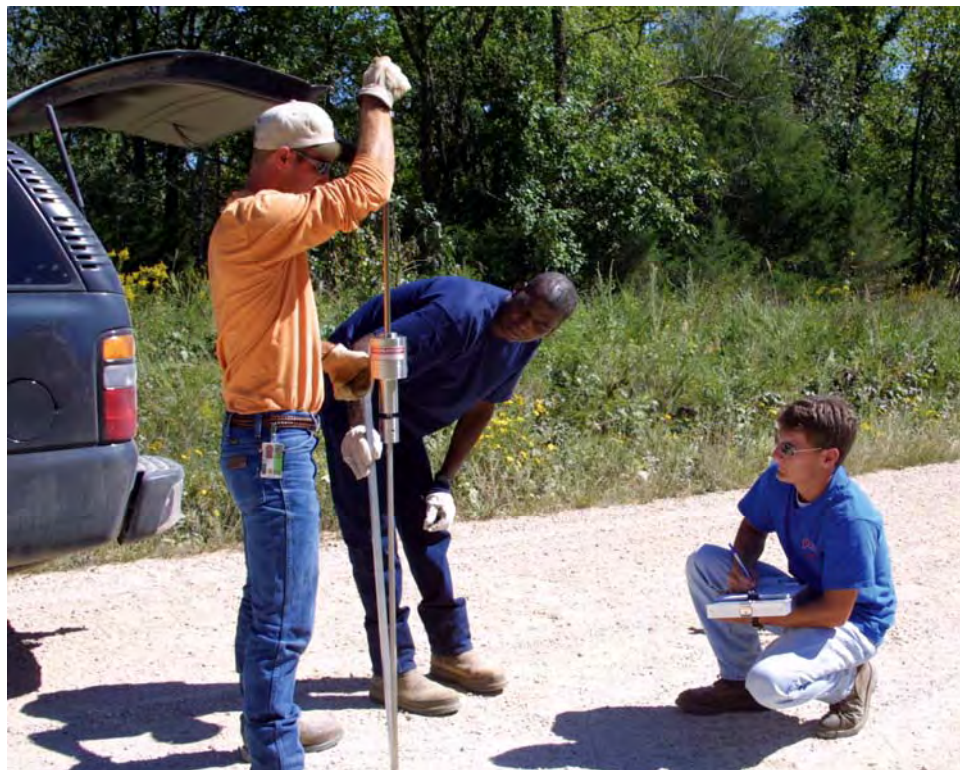
Photo 2. Dynamic cone penetrometer

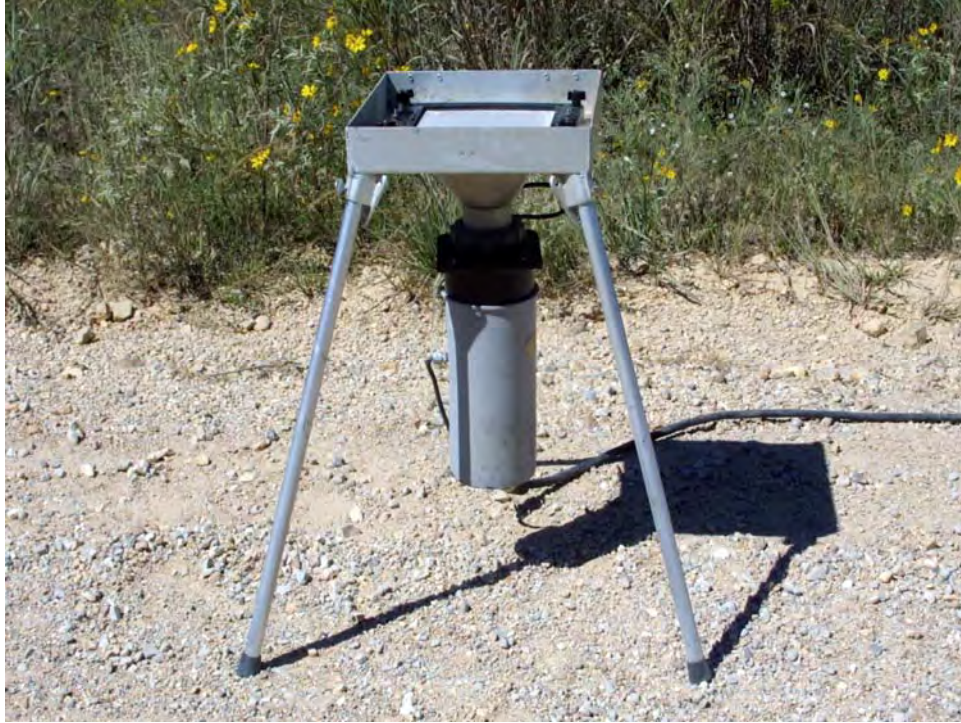
Photo 3. Stationary dust collection system

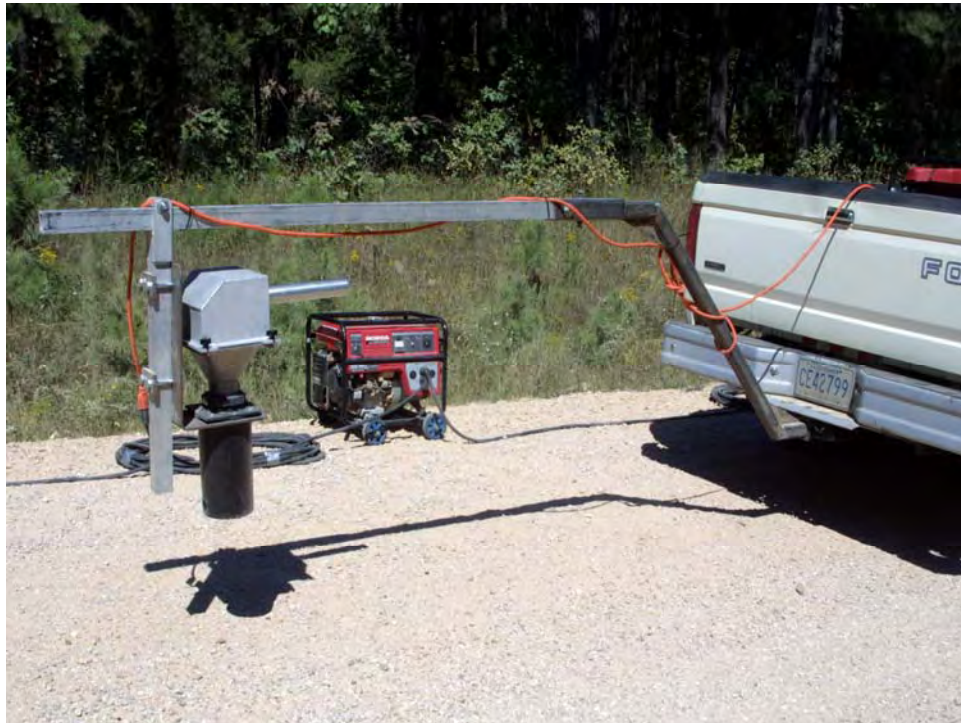
Photo 4. Mobile dust collection system

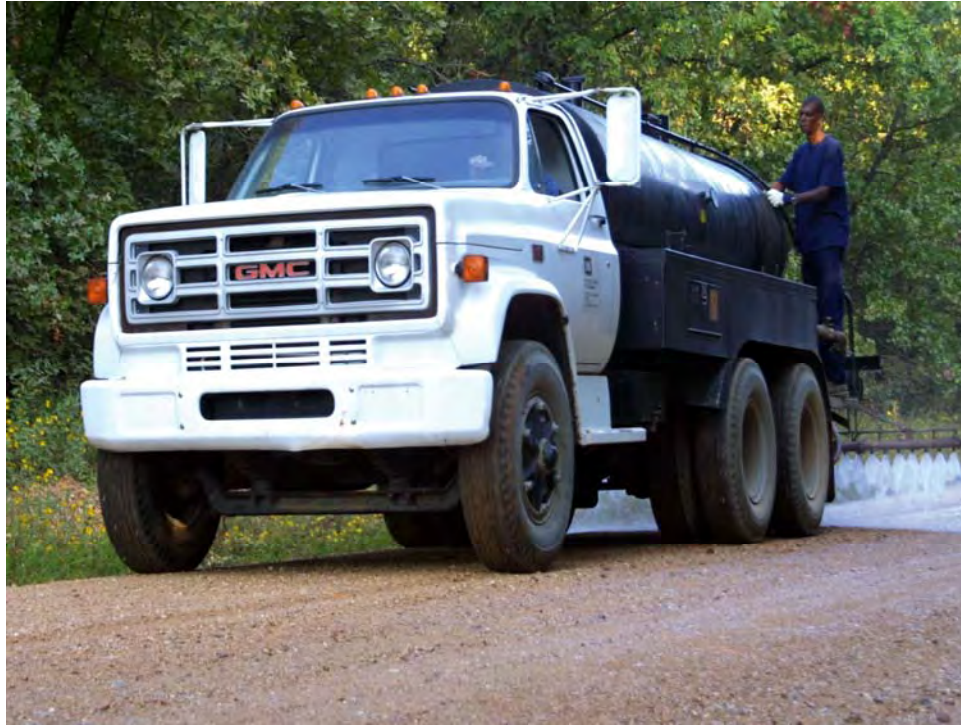
Photo 5. Etnyre asphalt emulsion distributor

- a. An Etnyre asphalt emulsion distributor was effective for spraying each of the dust palliatives. It provided a controlled application rate with even distribution. However, using the polymer emulsions in the equipment may cause maintenance problems if the polymers begin to harden in the tank or within the distribution pipes and valves.
- b. A TEREX soil reclaimer/stabilizer provided excellent mixing for incorporating the dust palliatives in the respective road section. It also provided precise control over the tilling depth.
- c. A 12-ton vibratory compactor was unable to achieve the original density of the road sections with only three coverages. Compactors with greater

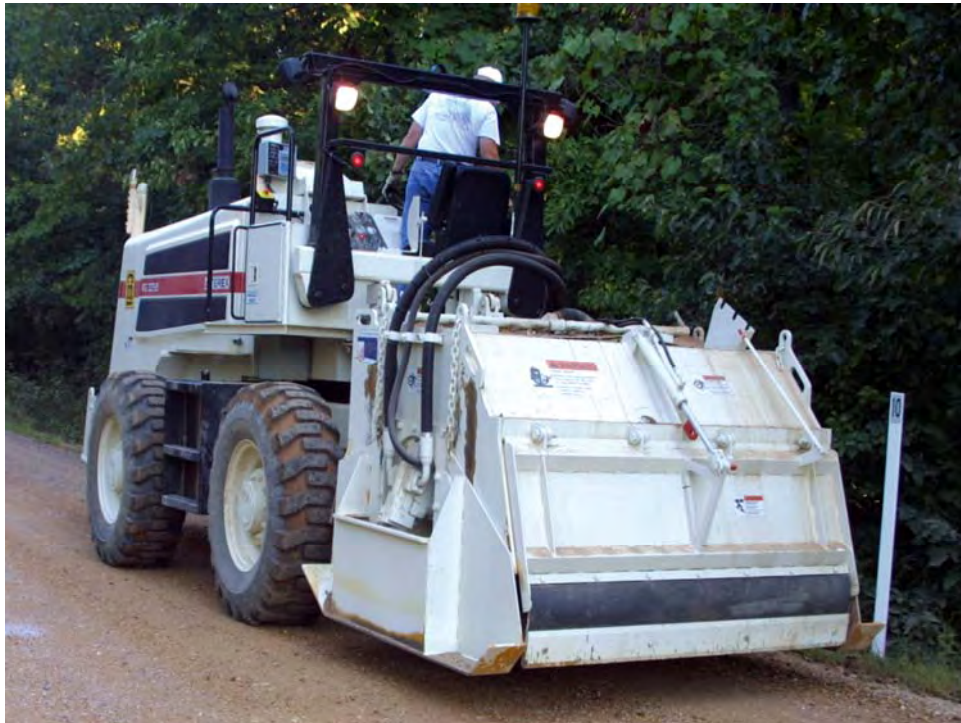
Photo 6. TEREX soil reclaimer/stabilizer

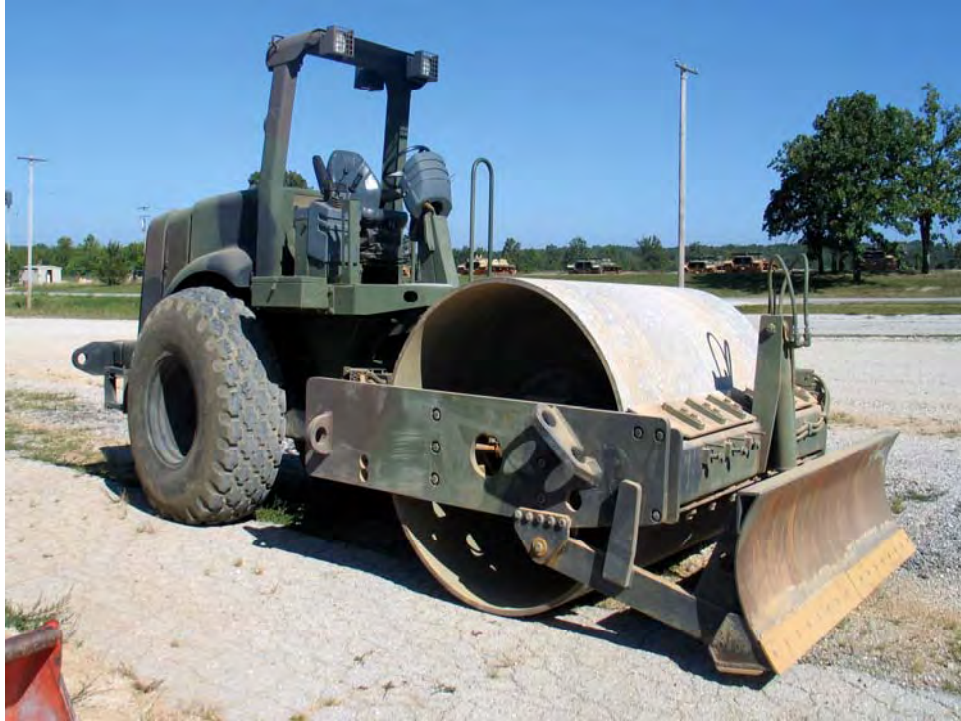
Photo 7. Caterpillar 12-ton vibratory roller

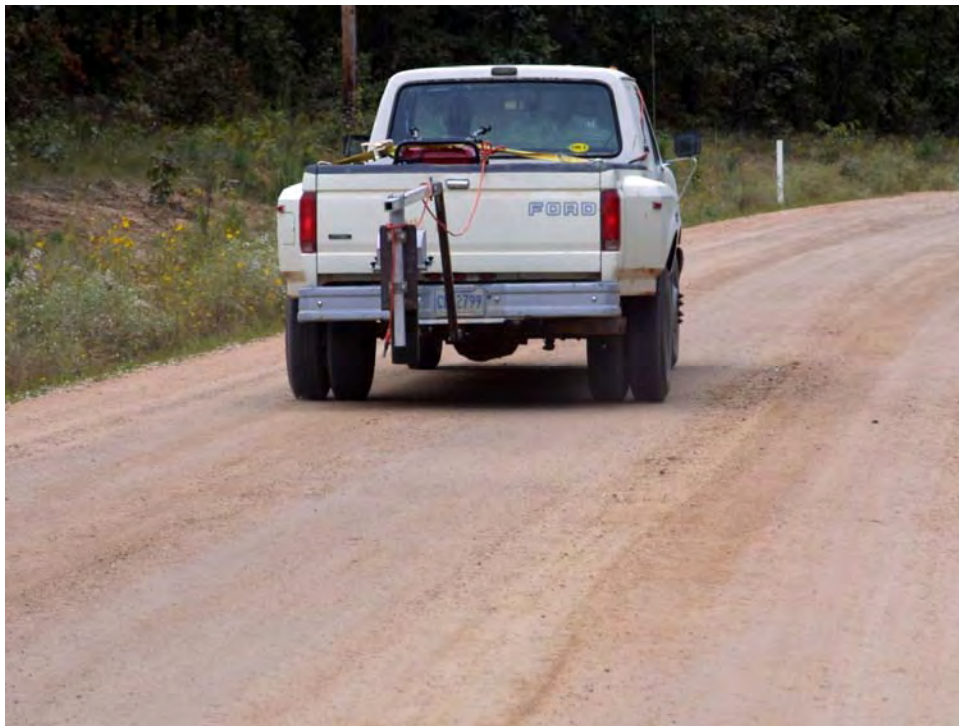
Photo 10. Section 1 after treating with Envirotac II® (0.8 gsy admix)

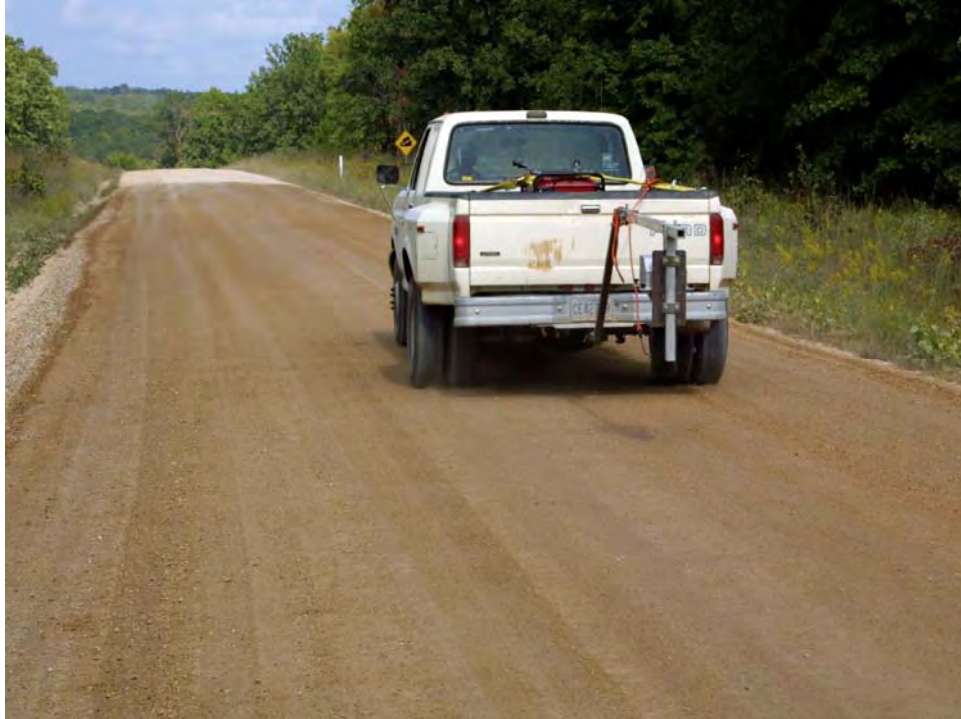
Photo 11. Section 5 after treating with Surtac® (0.8 gsy admix)

The fifth section used the same construction method to place Surtac®. The section was prewet with 0.4 gsy of water and then sprayed with 0.4 gsy of a 3:1 water:Surtac® solution. The section was tilled to a depth of 2 in. using three passes of the TEREX. The ends of the section were smoothed using the Kubota tractor, and the section was compacted with three coverages of the 12-ton vibratory roller. A final 0.4 gsy of a 3:1 solution of water and Surtac® was applied to the road topically to provide a sealed wearing surface. The section had a smooth, tight final surface with polished wheel paths and loose gravel covering less than 5 percent (Photo 11).

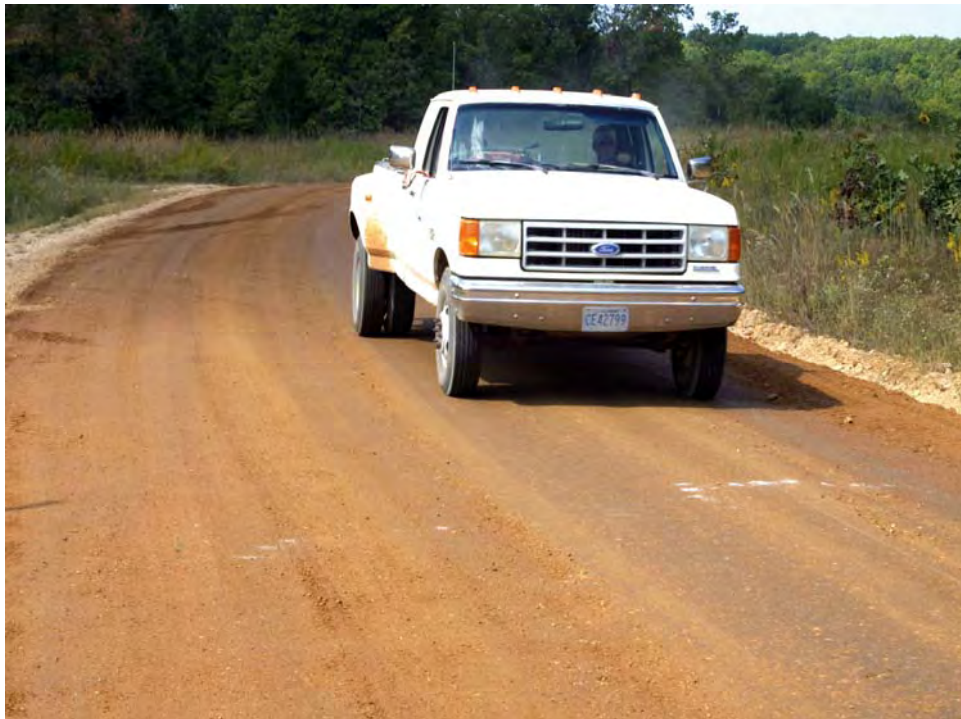
Photo 12. Section 6 after treating with calcium chloride (0.8 gsy admix)

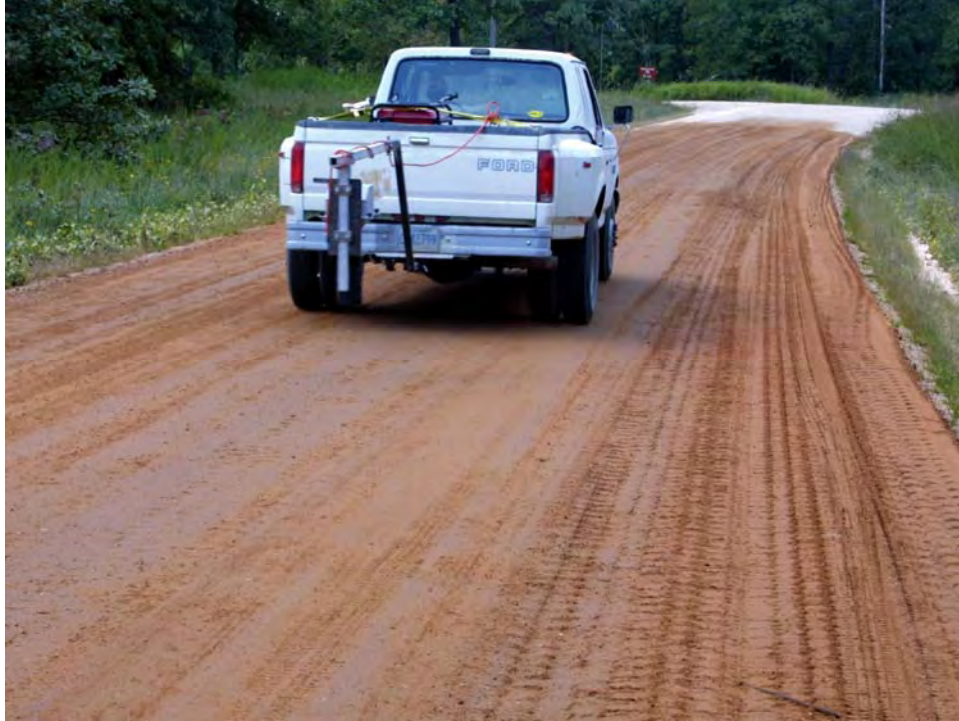
Photo 13. Section 7 after treating with Durasoil® (0.8 gsy admix)

The seventh section was treated with Durasoil®. The section was prewet with 0.4 gsy of water and then sprayed with 0.4 gsy of Durasoil®. The section was tilled to a depth of 2 in. using three passes of the TEREX. The ends of the section were smoothed using the Kubota tractor, and the section was compacted with three coverages of the 12-ton vibratory roller. A final 0.4 gsy of the Durasoil® was applied to the road topically to increase the effectiveness of dust abatement at the surface. The section had a smooth surface with polished wheel paths that were slightly rutted. Loose aggregate covered approximately 2 percent of the surface area at the northeast end. The Durasoil® caused the soil to appear much darker than the surrounding material (Photo 13).

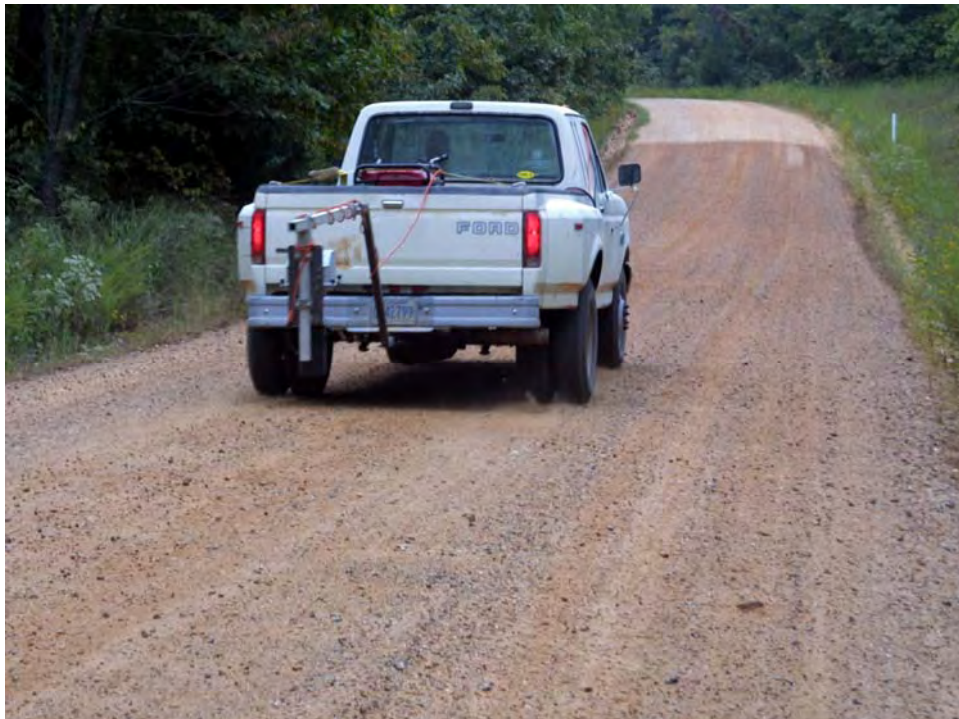
Photo 14. Section 13 after topical application of calcium chloride (0.4 gsy)

Sections 13 through 17 were designed to test the effect of application procedures on dust palliative performance. They were each constructed using topical applications of 0.4 gsy after an initial prewet with 0.4 gsy of water. Two polymer emulsions, one calcium chloride solution, and one synthetic fluid were chosen for these sections, along with one section treated with only water for comparison. Section 13 was first prewet with 0.4 gsy of water and then sprayed with 0.4 gsy of a 38 percent by weight solution of calcium chloride. The section had a rough surface with potholes and scattered loose aggregate covering the entire area. The calcium chloride produced a significant color change to the section and provided visual evidence of its location (Photo 14).

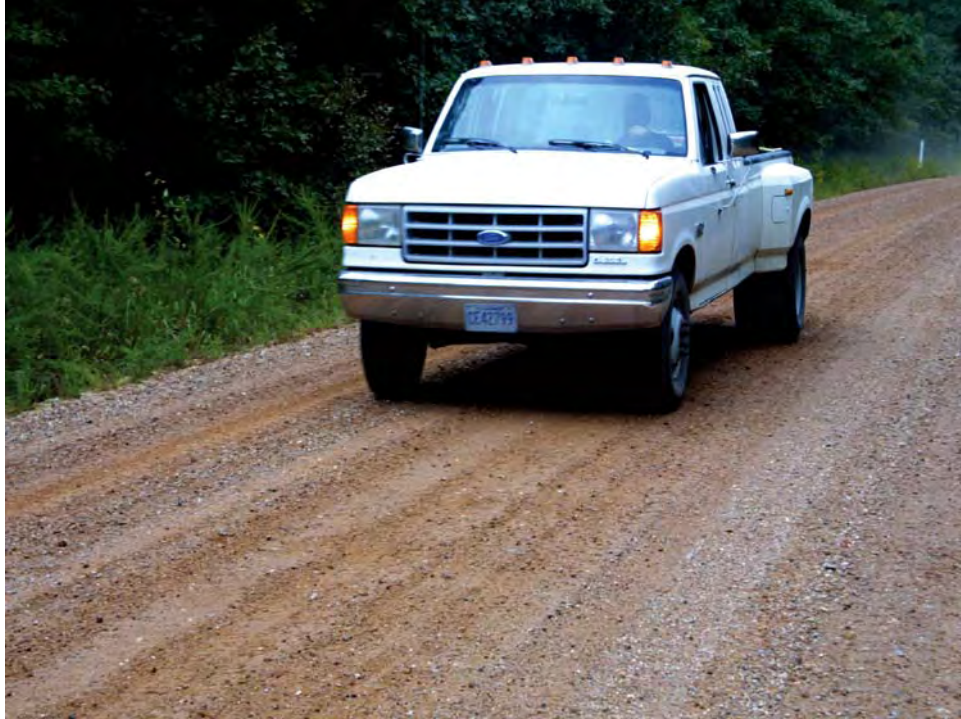
Photo 15. Section 14 after topical application of Durasoil® (0.4 gsy)

Section 14 was treated with a topical application of Durasoil®. It was first prewet with 0.4 gsy of water and then sprayed with 0.4 gsy of Durasoil®. The section had some densification in the wheel paths and scattered loose gravel over 60 to 70 percent of the surface. The Durasoil® produced a significant color change to the section and provided visual evidence of its location (Photo 15).

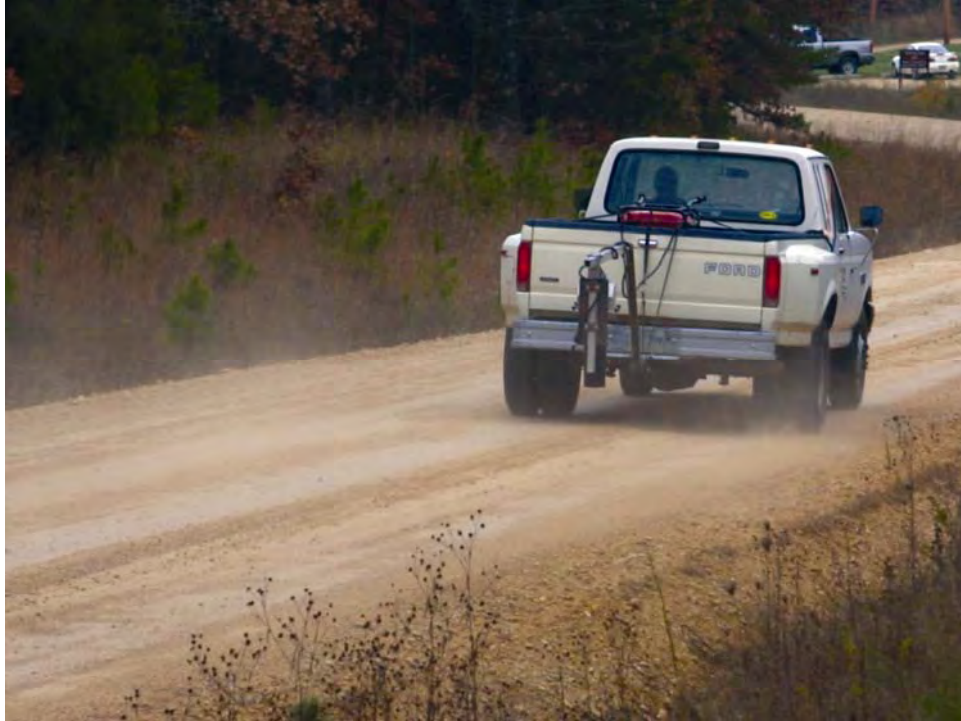
Photo 19. Light dust produced on section 3 (M10 + 50® 0.8 gsy admix) during 30-day evaluation

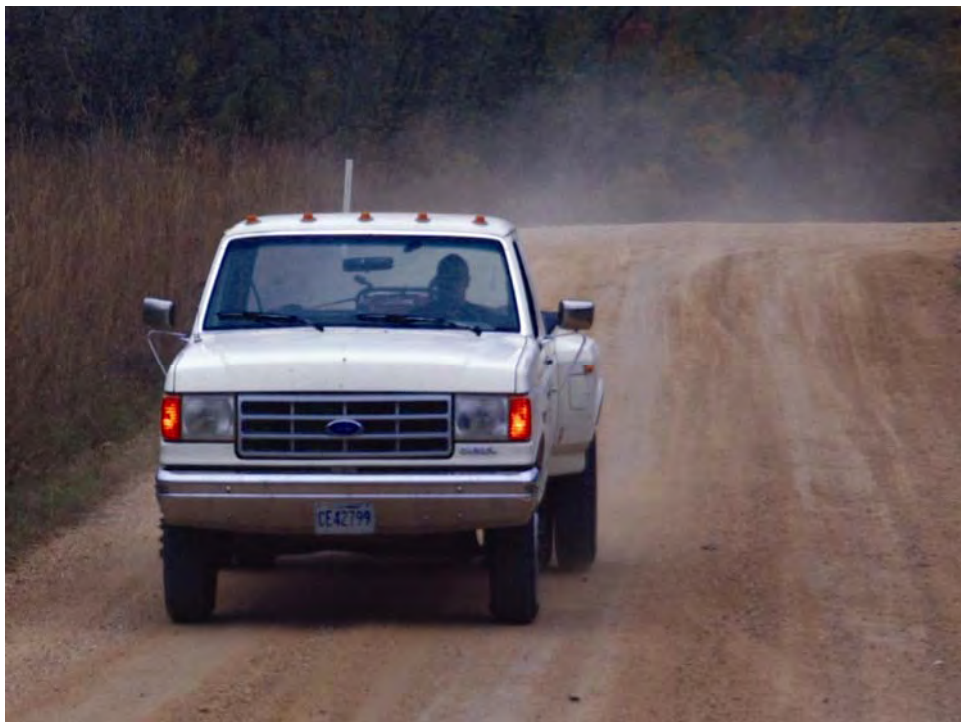
Photo 20. Light dust produced on section 4 (Soil Sement® 0.8 gsy admix) during 30-day evaluation

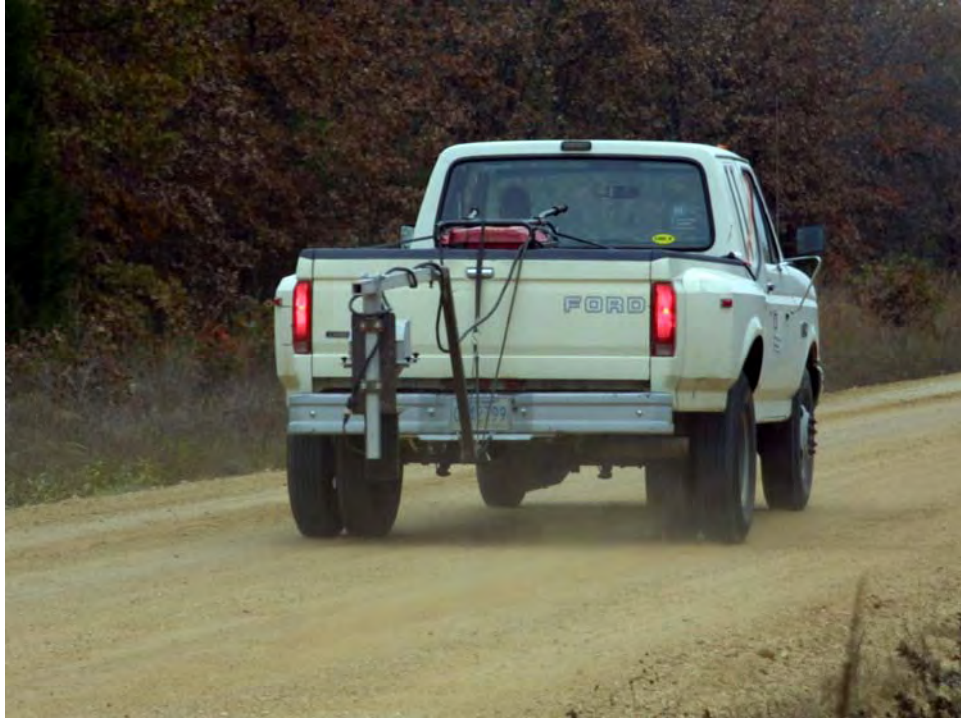
Photo 21. Excellent dust reduction on section 5 (Surtac® 0.8 gsy admix) during 30-day evaluation

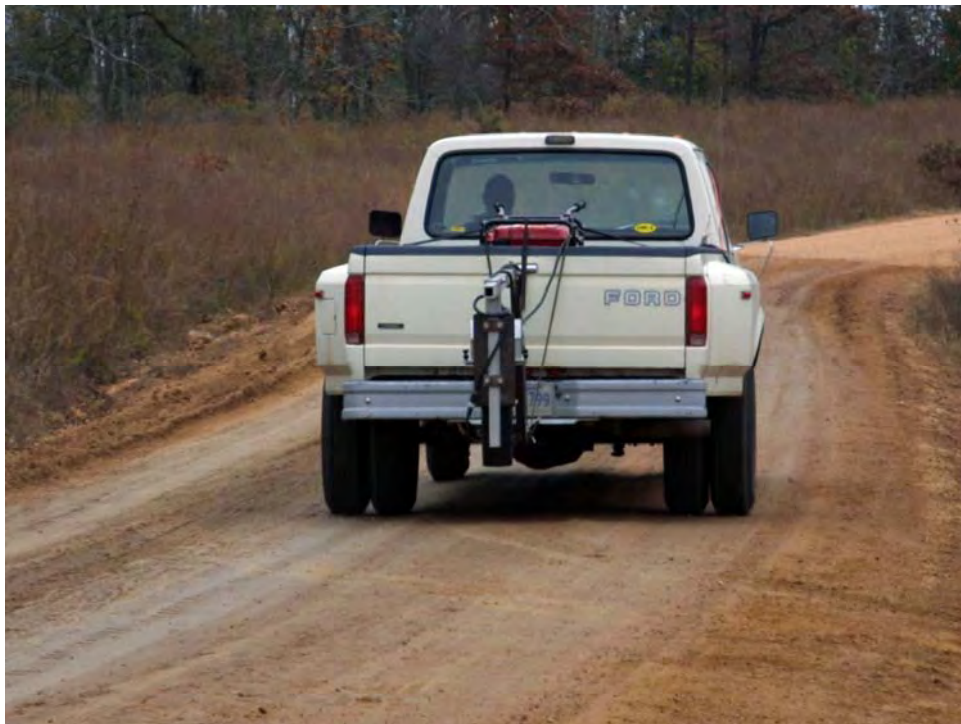
Photo 22. Absence of dust on section 6 (calcium chloride 0.8 gsy admix) during 30-day evaluation

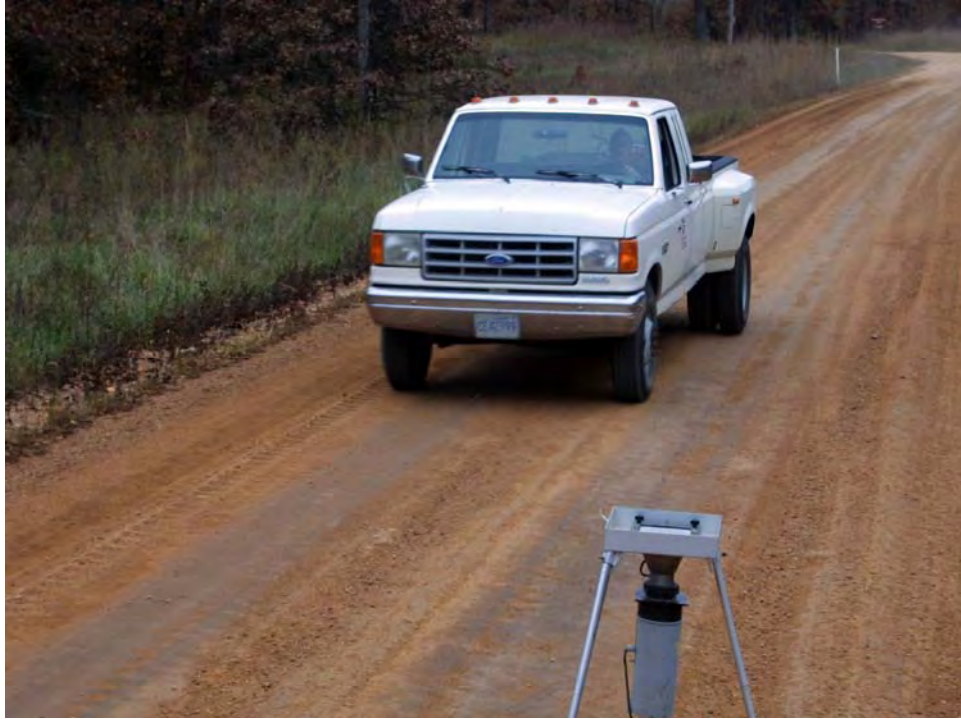
Photo 23. Absence of dust on section 7 (Durasoil® 0.8 gsy admix) during 30-day evaluation

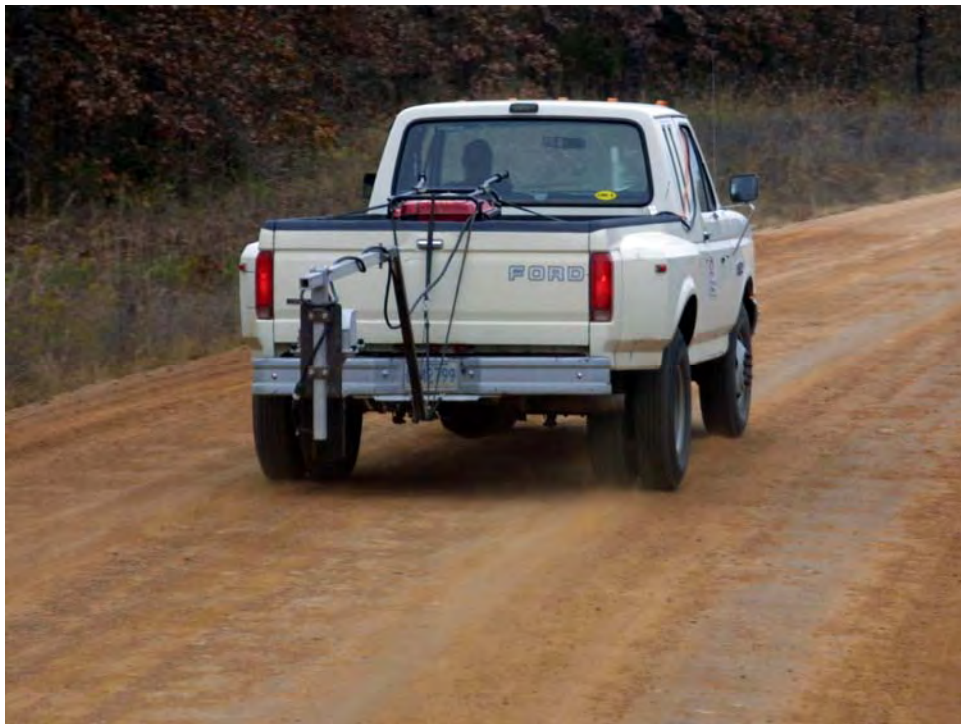
Photo 24. Absence of dust on section 8 (Envirokleen® 0.8 gsy admix) during 30-day evaluation

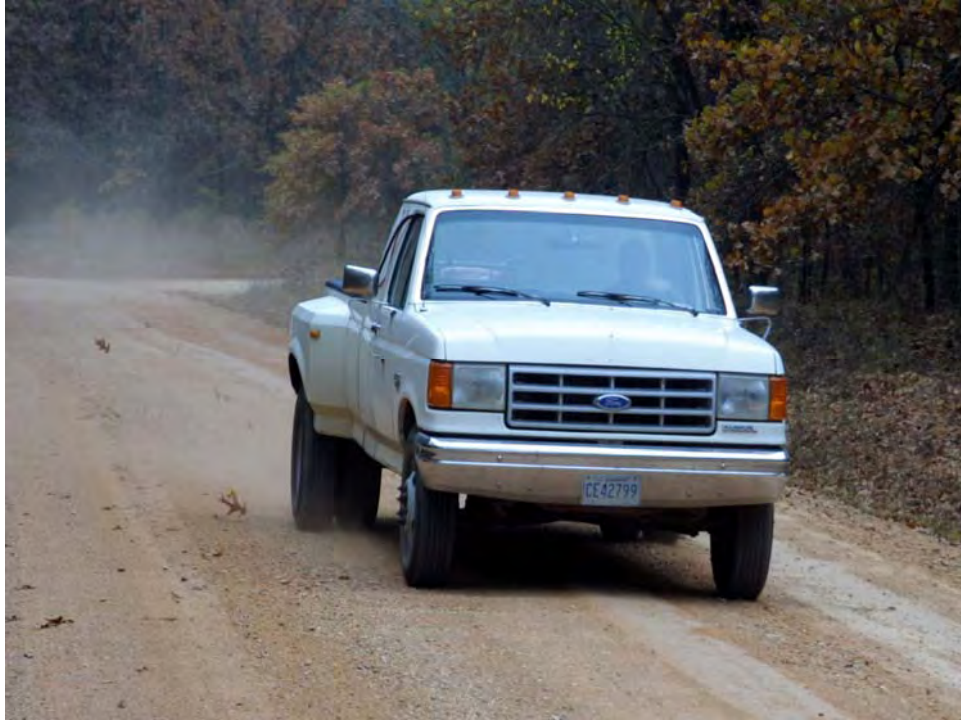
Photo 25. Dust generated on section 10 (Soiltac® 0.4 gsy admix) during 30-day evaluation

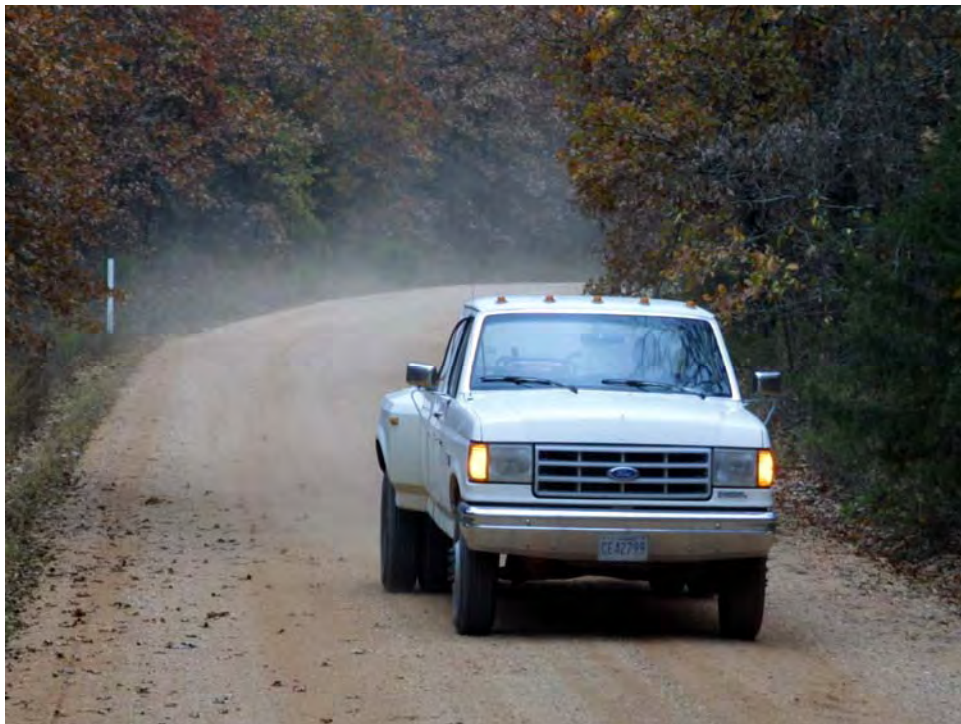
Photo 26. Dust generated on section 11 (Envirotac II® 0.4 gsy admix) during 30-day evaluation

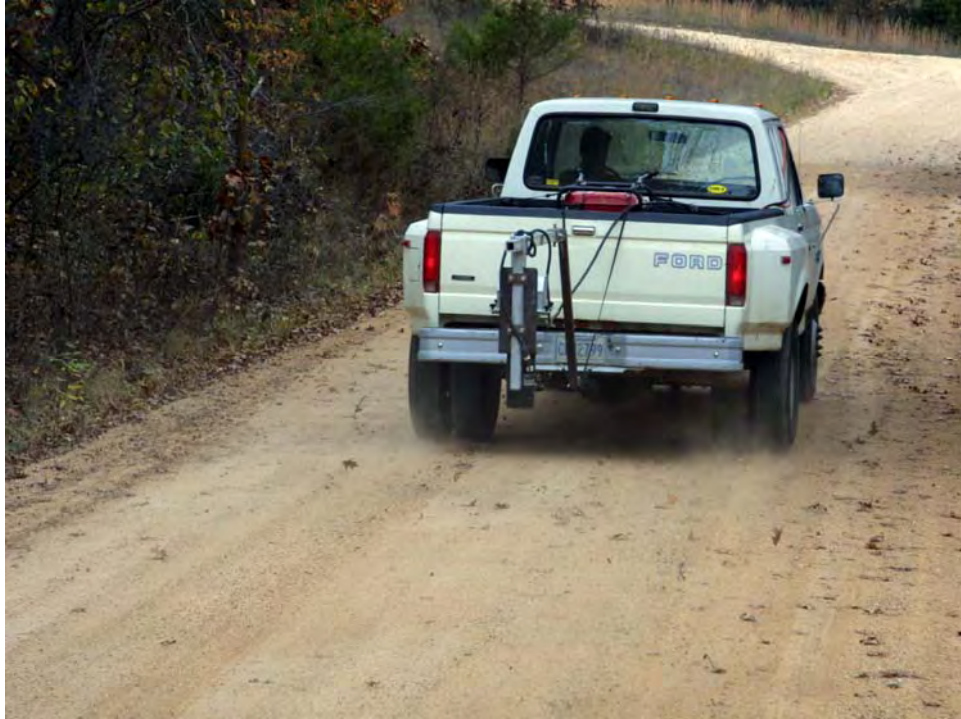
Photo 27. Dust generated on section 12 (Surtac® 0.4 gsy admix) during 30-day evaluation

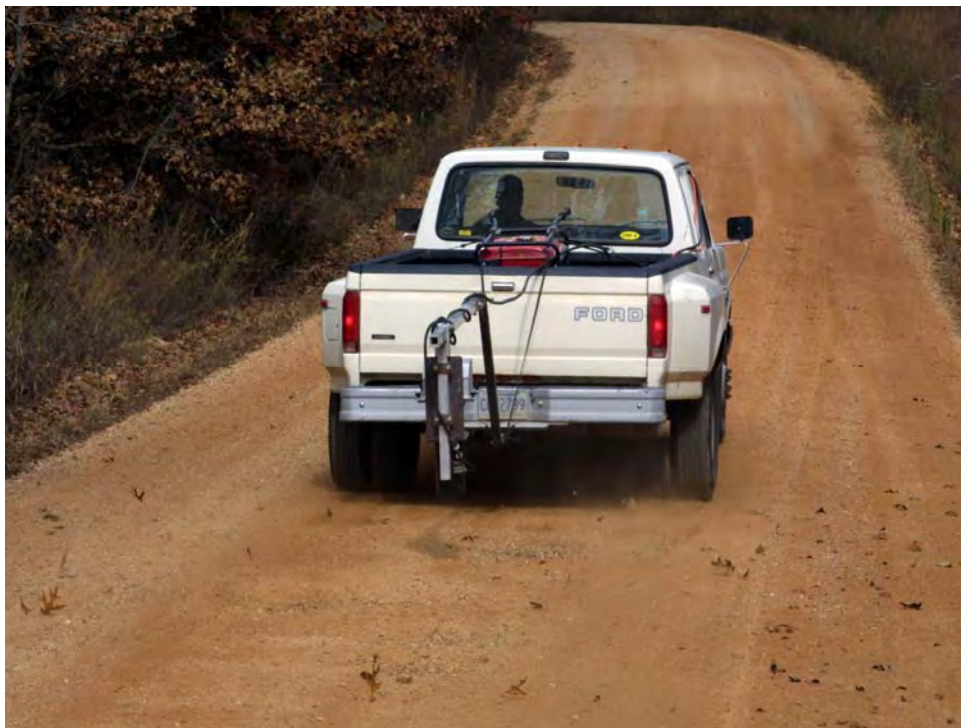
Photo 28. Dust generated on section 13 (Calcium Chloride 0.4 gsy topical) during 30-day evaluation

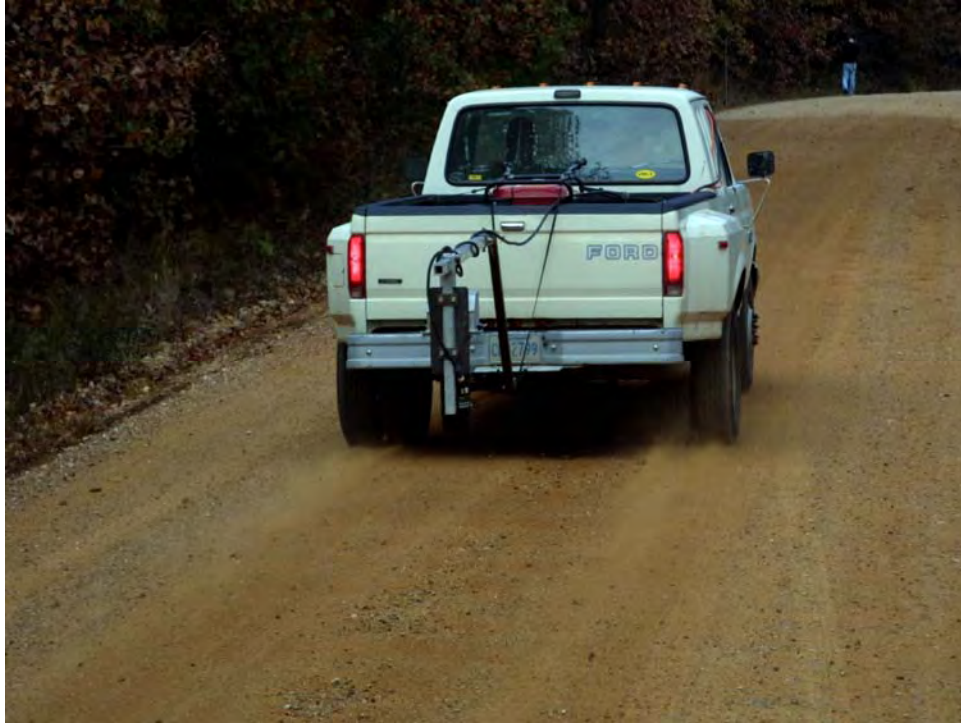
Photo 29. Dust generated on section 14 (Durasoil® 0.4 gsy topical) during 30-day evaluation

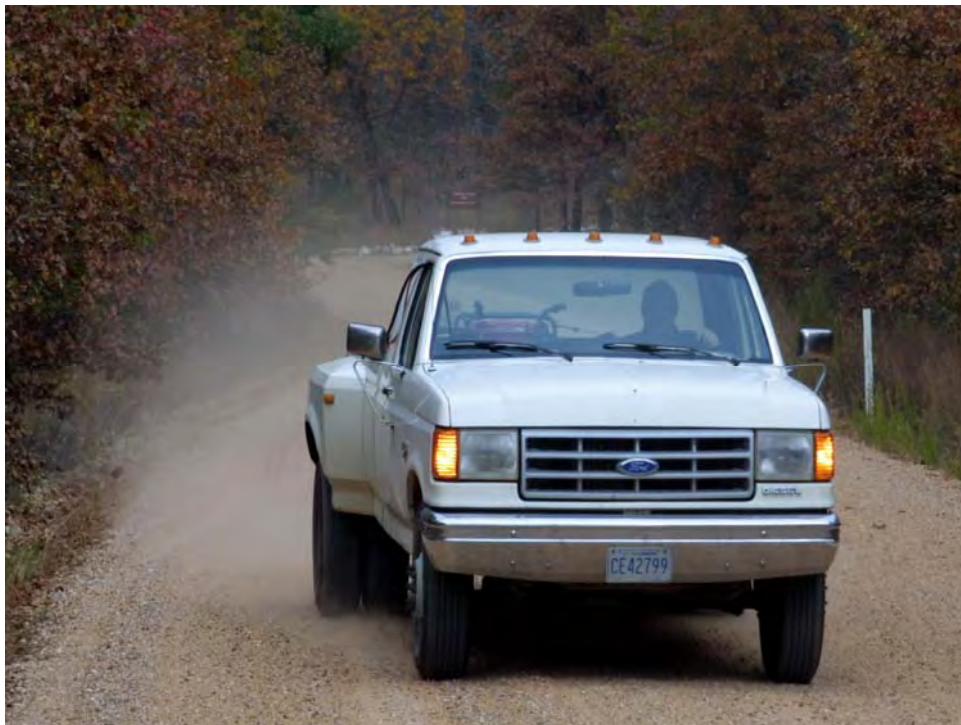
Photo 30. Dust generated on section 15 (Envirotac II® 0.4 gsy topical) during 30-day evaluation

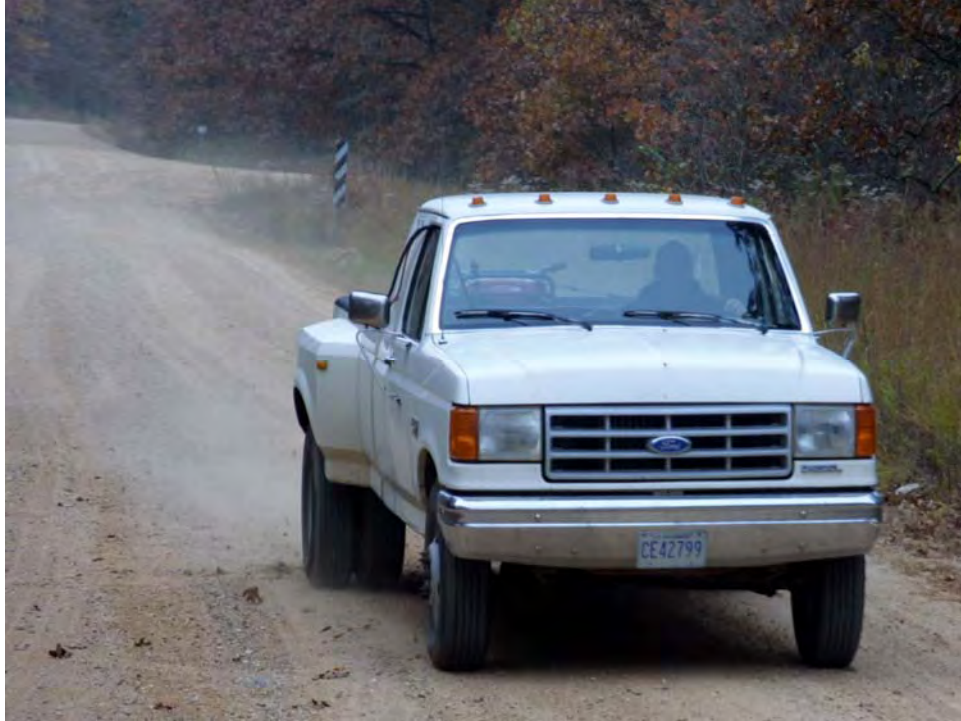
Photo 31. Dust generated on section 16 (water 0.4 gsy topical) during 30-day evaluation

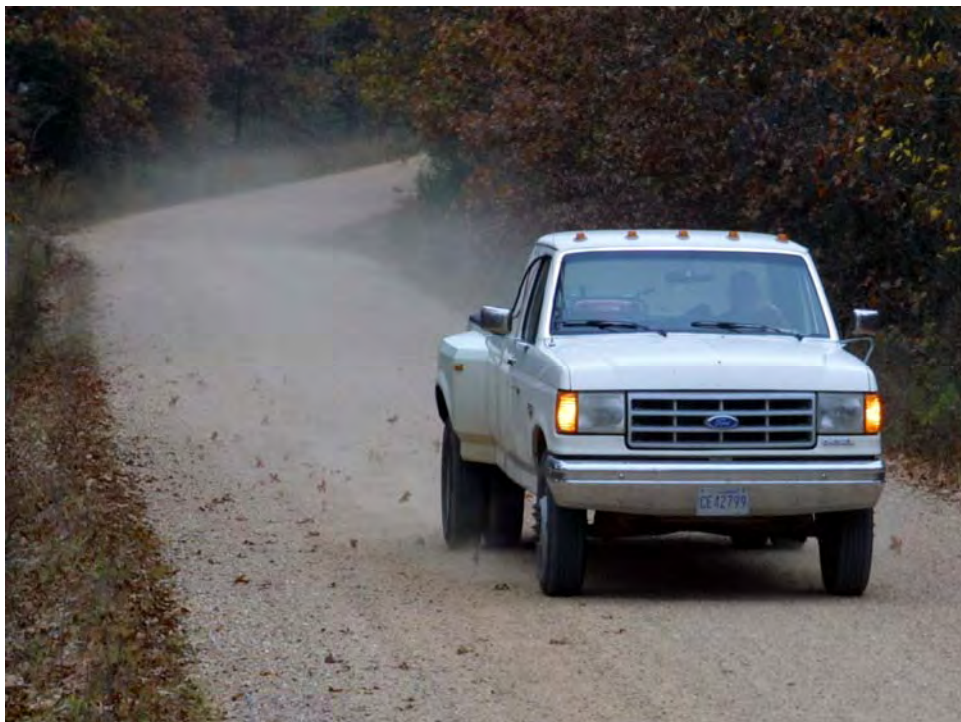
Photo 32. Dust generated on section 17 (Soiltac® 0.4 gsy topical) during 30-day evaluation

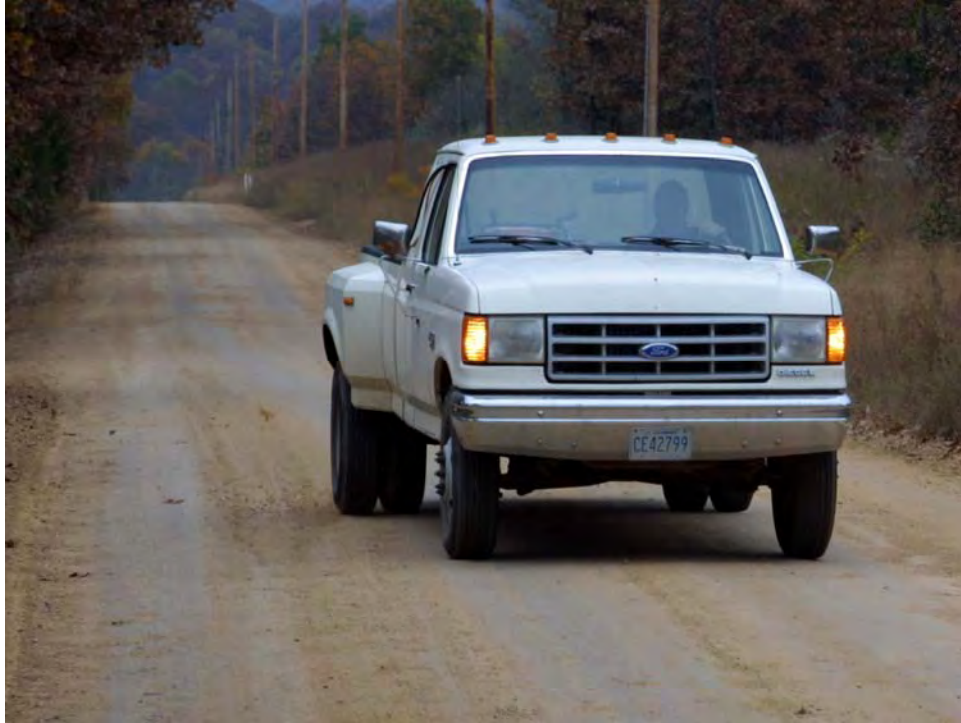
Photo 33. Dust generated on section 18 during 30-day evaluation

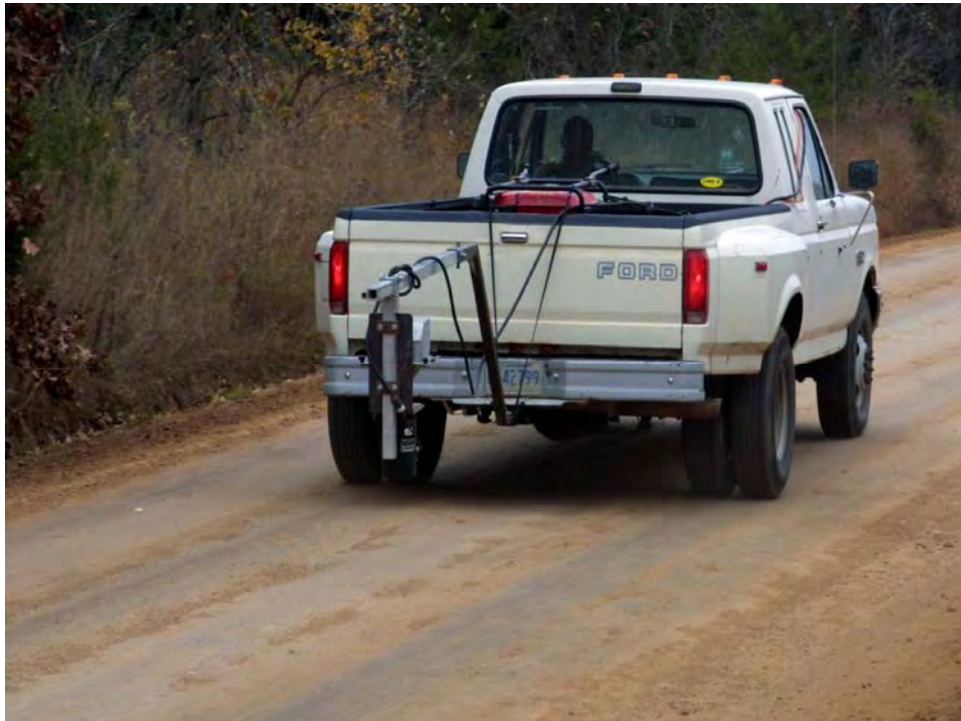
Photo 34. Dust generated on section 19 (Durasoil® 0.8 gsy topical) during 30-day evaluation
